# Inspection Report

# PROPERTY INSPECTION REPORT

**Concerning:** Buyers Row, Our Town, TX  
(Address or Other Identification of Inspected Property)

**By:** Sean Kennedy #22935 Bill Harvey #5648 9/4/2020  
(Name and License Number of Inspector) (Date)

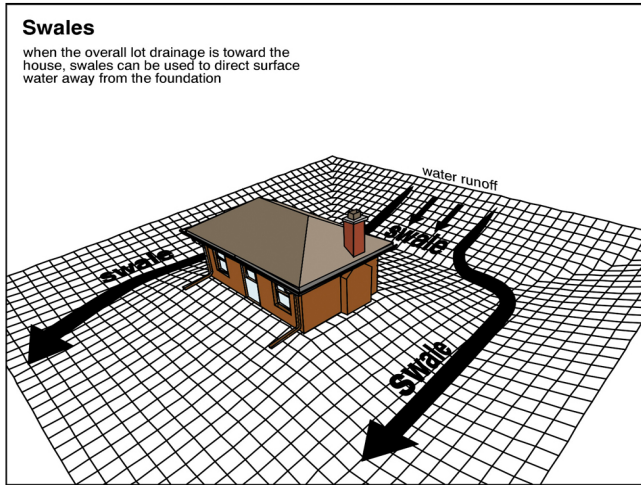
- Grade improvements are needed to direct run off away from the foundation at the left side and rear of the home. Code requires six inches minimum of fall from the foundation in the first ten feet

of grade. Improper grading may promote unstable foundation conditions and water penetration into the home. Improvements should be undertaken by professional landscaper.

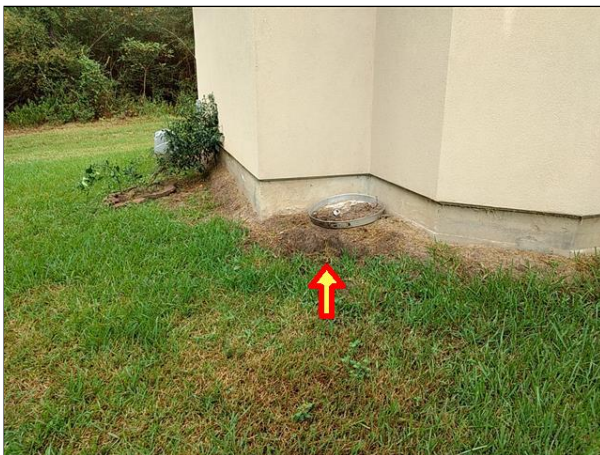
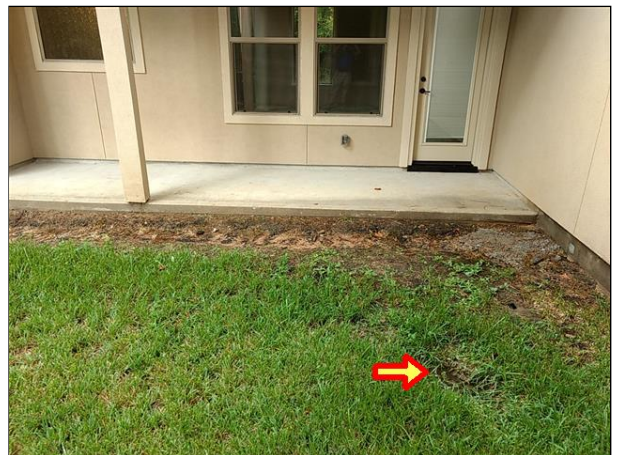
- Soil erosion from runoff from the roof at the rear of the home was observed. It is recommend to make improvements, such as gutters or landscape design, to control the runoff and limit soil erosion.

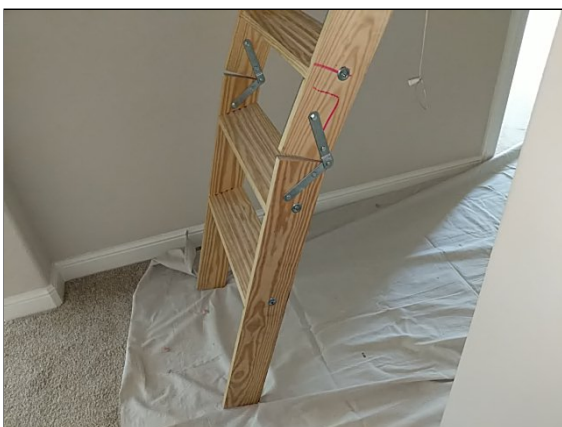
- The bottom section of the folding attic stairway is cut to an improper length. This condition places additional stress on the ladder system making it unsafe to use. Repairs should be undertaken.

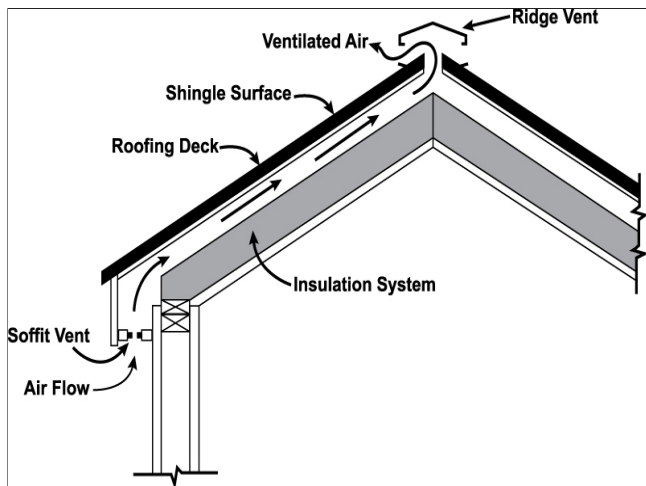
Attic Venting

- The attic space has inadequate or missing venting at the roof. Venting is required and necessary to remove heat and humidity from the attic space. A qualified contractor should be consulted.

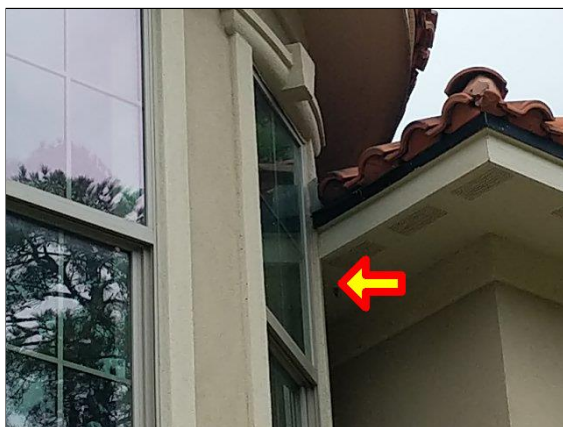
Test these areas

- The Client should be aware this a limited inspection based on visual observations only, most from ground level. This inspection does not include destructive testing such as substrate moisture testing, or removal of plaster to inspect suspicious areas. It is possible some deficiencies / defects may not be detected.
- **In the Inspectors opinion, some are are in need of further testing.** At minimum, the area under the rear balcony, and the one area at the front should be tested. for excessive moisture or substrate damage. This is considered destructive testing and requires written from the property owner. Testing is performed by drilling two 1/4 of one inch holes at east test location. After the test, the hole are filled with sealant.

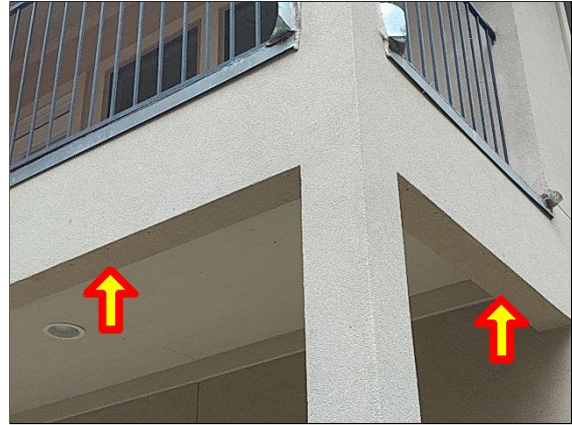
Missing moisture relief detail

- A moisture relief detail is not installed under the the elevated vertical to horizontal transition at the rear of the home. Moisture relief is needed at the lower edge of elevated walls just as moisture relief is need at walls that terminate near the foundation level. Moisture relief can by

- Cracks have formed on the column below this area suggesting water intrusion into the wall system.

created at elevated walls by installing aluminum slotted tracks designed for this purpose, or casing bead can be used to create a small opening. If not repaired structural damage in the wall may occur.

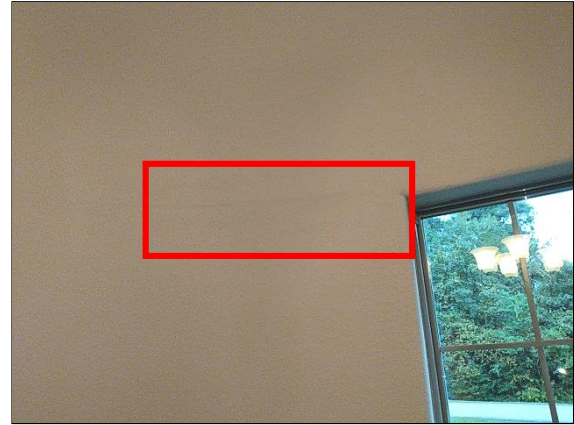
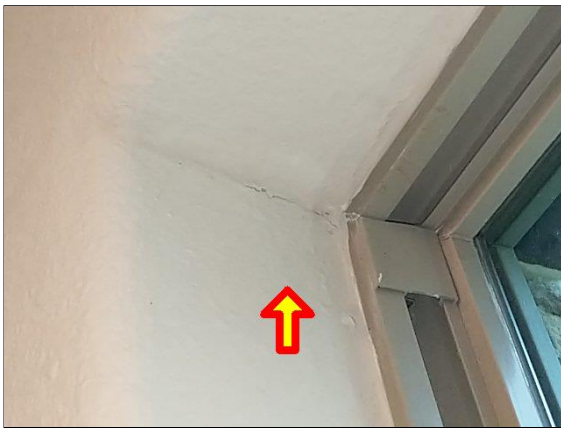
- At the front of the home, the kickout terminates into the window trim band. Terminating the roof edge this close to the window opening can be problematic. What appears to be evidence of water intrusion was observed at the interior.

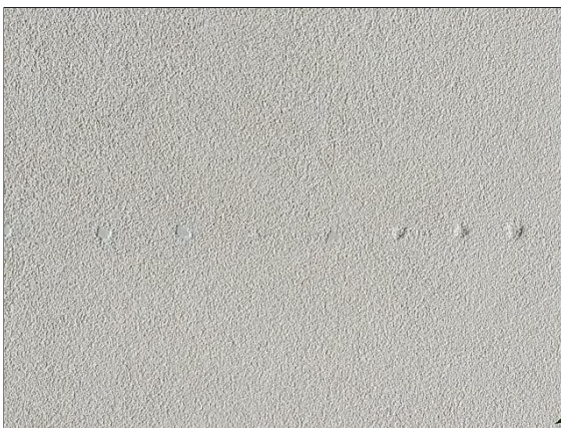
- Damaged finish at the master bedroom rear exterior wall needs repair.

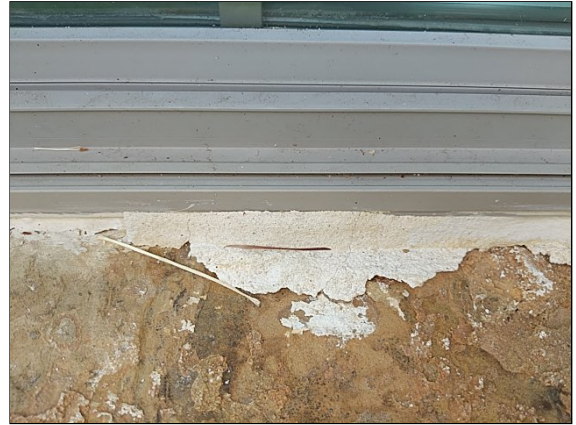
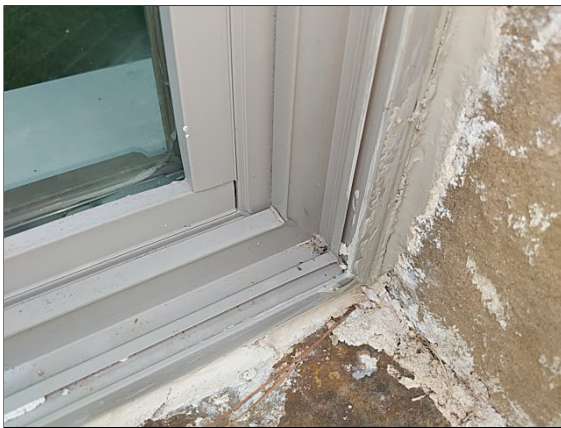
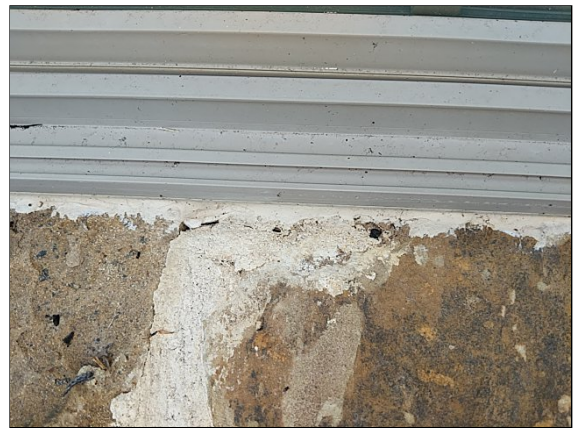
- Caulking at windows is failing. Caulking improvements should be undertaken as needed.

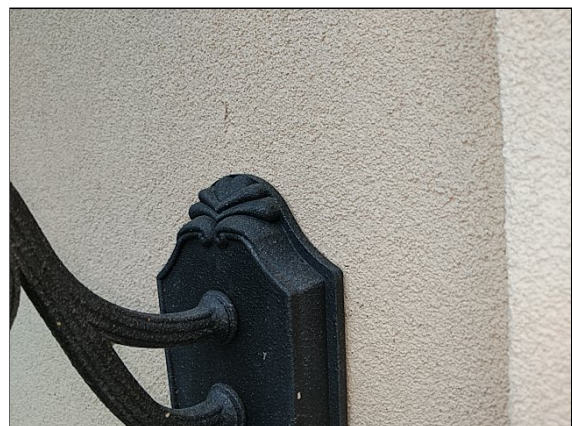
- Caulking at the exterior light(s) is not installed. Caulking improvements should be undertaken as needed.

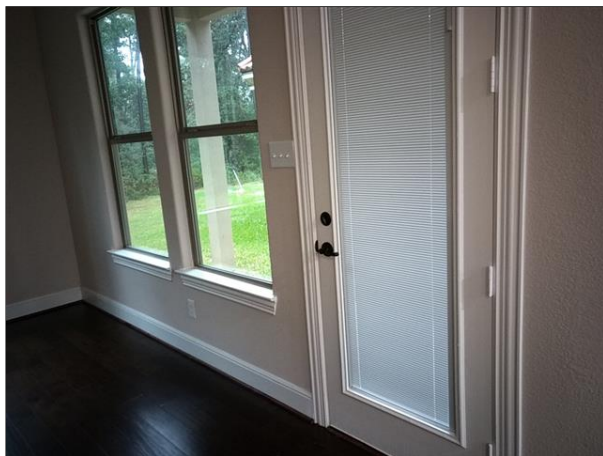
- The self closing hinges at the garage entry door need adjustment to close the door. Doors between attached garages and living space are required by current standards to be self closing.
- The exterior door at the family room was observed to have the following deficiencies: door does not latch. The door should be adjusted to function properly.

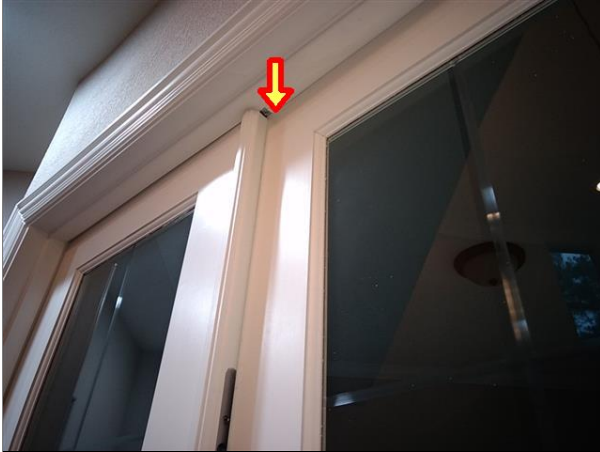
- The interior door at the study has the following defects: door rubs at opposing door when closing.

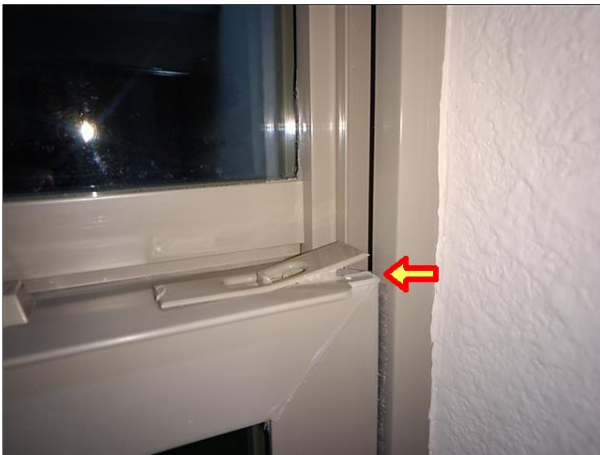
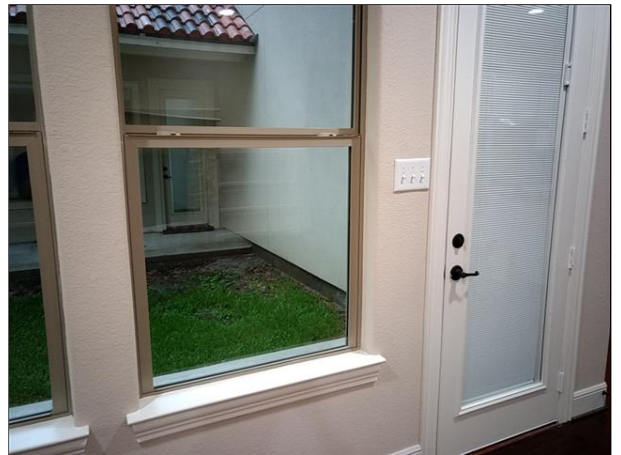
- Damaged window hardware in family room was observed.

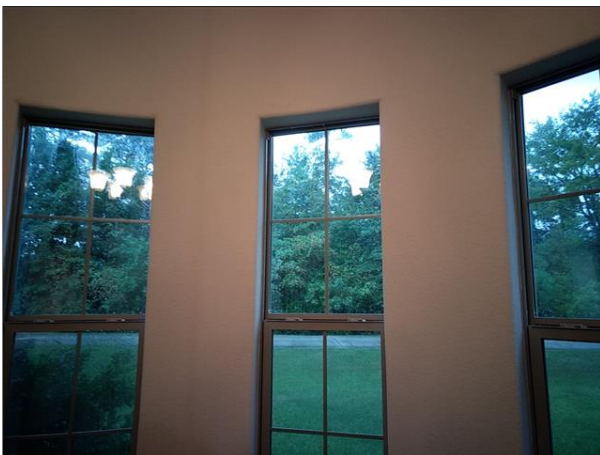
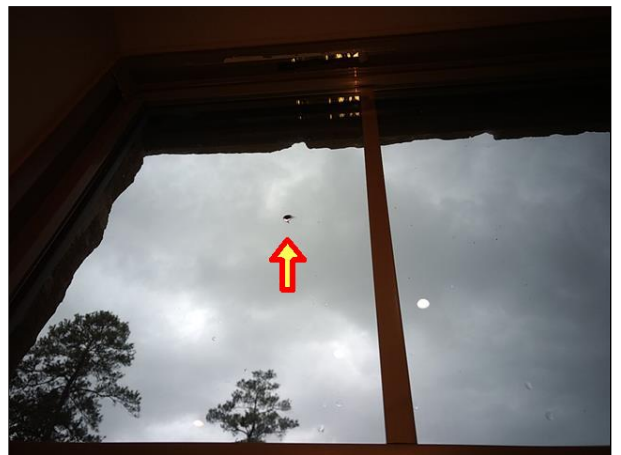
- The glass at one window(s) in the dining room is cracked.

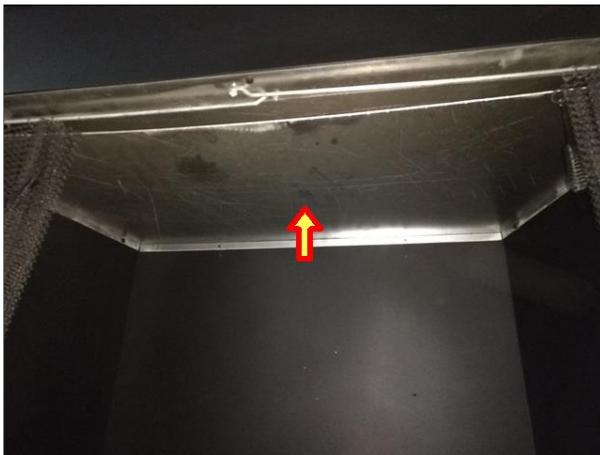
No chimney vent

- The fireplace in the family is not suitable to burn wood. The noncombustible hearth does not extend far enough and a chimney to the exterior is not present. The bottom of the firebox is thin gauge metal. and appears to have been poorly modified from its original design. Modifications of the current fireplace will be necessary to configure the fireplace to burn wood or use gas logs . Recommend consulting with a chimney sweep about recommend modifications necessary.

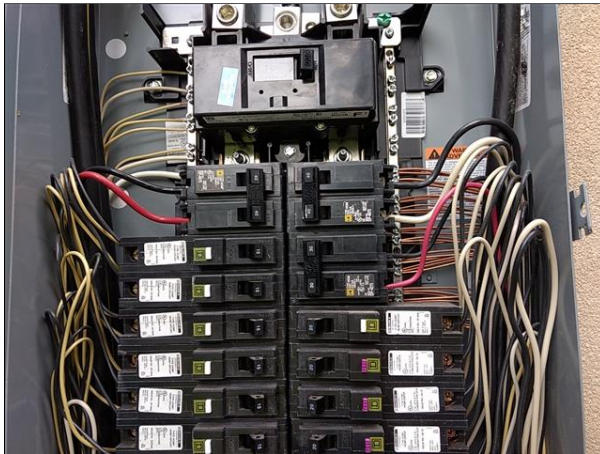
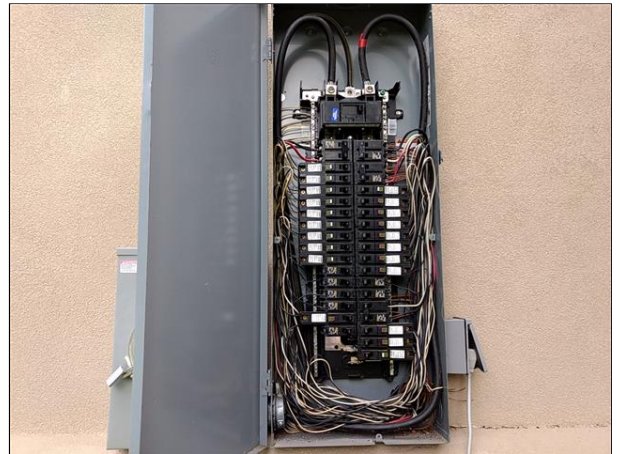
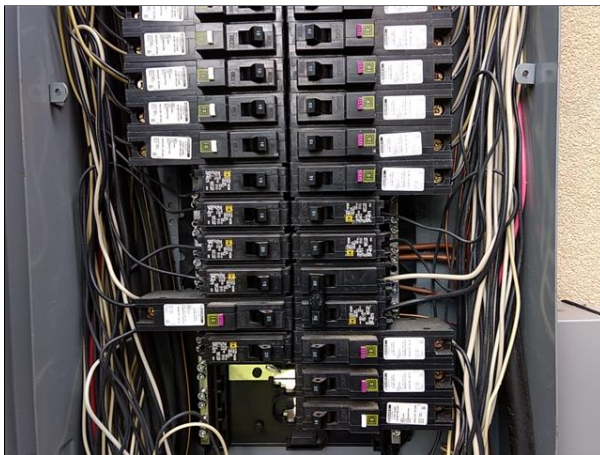
- The main panel enclosure was inspected with the deadfront removed. Conditions needing repair were observed. These repairs should be performed by a licensed electrician. Additional defects may be discovered when inspected by the licensed electrician.

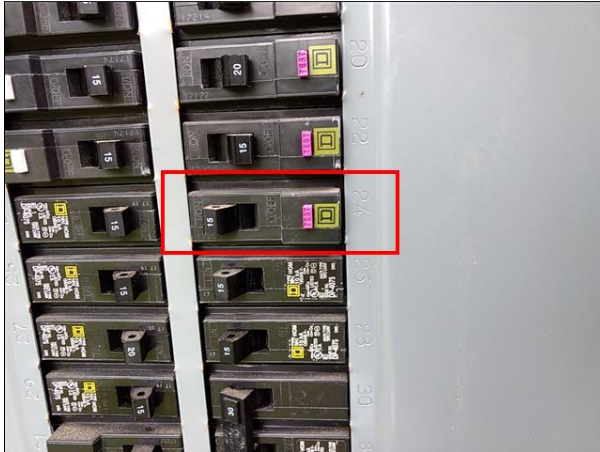
- The arc fault circuit interrupt (AFCI) located at #24 did not trip when tested. Repairs should be made by a licensed electrician.

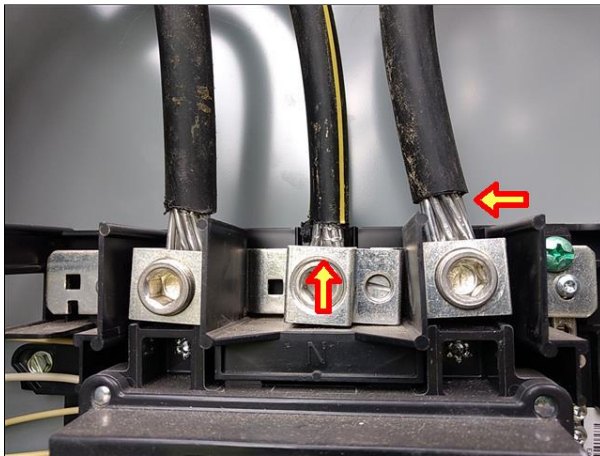
- Damage service conductors were observed where the sheathing was cut back at the terminal connections. Damaged wires should not have nicks, cuts or other forms of damage.

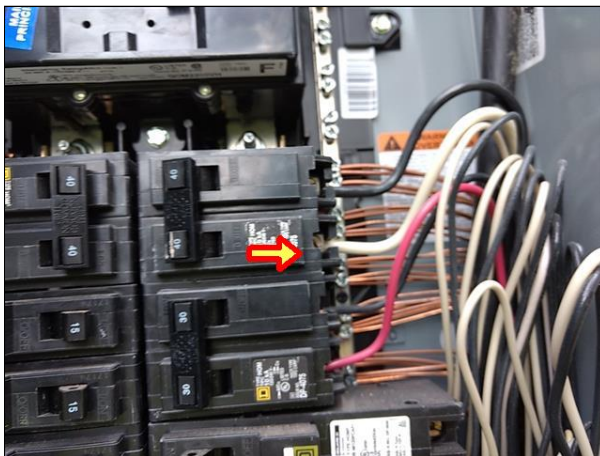
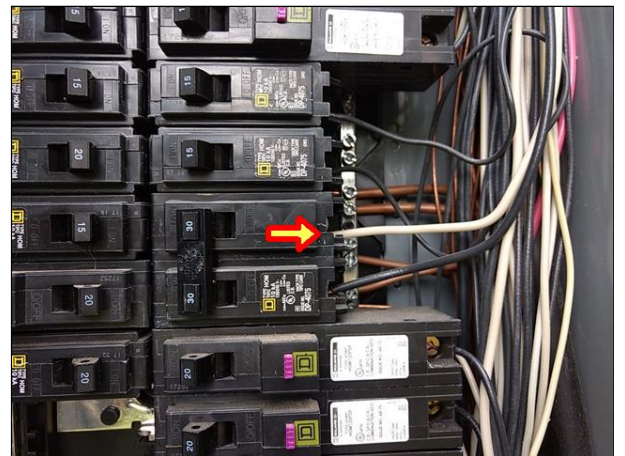
- "Hot" wires terminating at breakers in the main panel enclosure are improperly colored. These wires should be red or black in color. Marking the wires with a marker is acceptable.

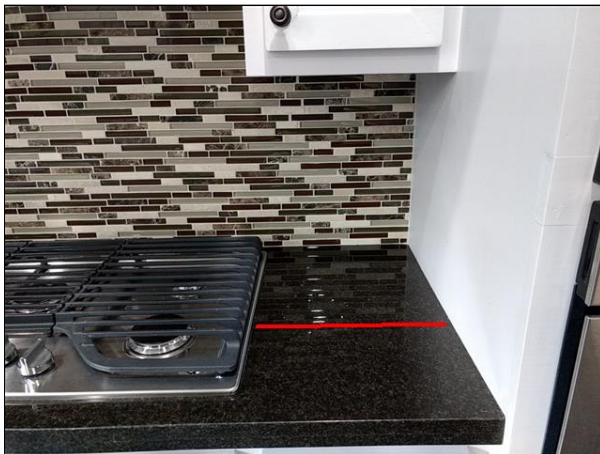
- Kitchen counter areas that are wider than 12 inches should have a receptacle installed.

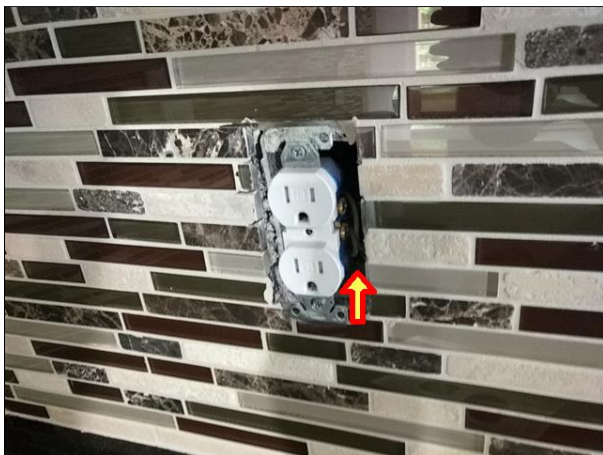
- Junction box extension are needed at the kitchen counters to bring the edge of the junction box flush with the edge of the finished wall surface.

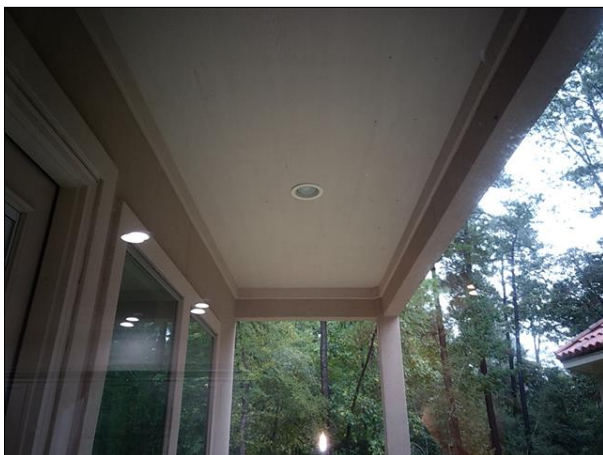
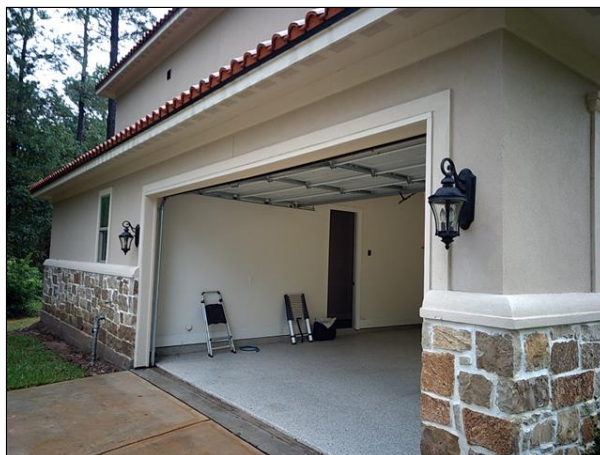
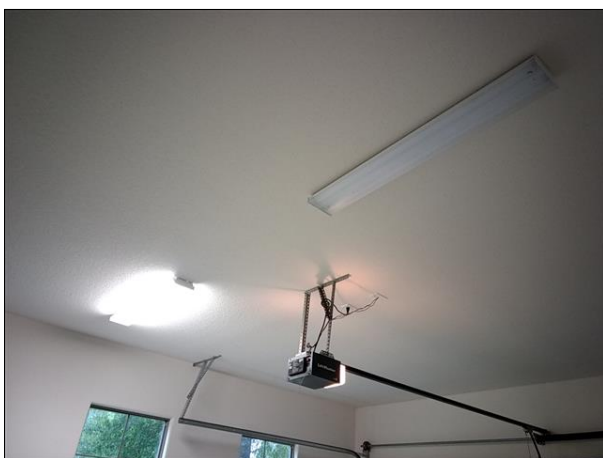
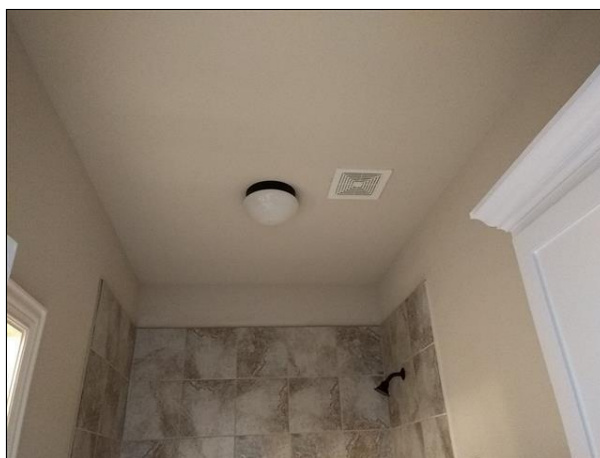
- Four or more light fixture(s) at the rear porch, the garage coach lights, second level bathroom and garage ceiling are inoperative. If the fixture does not work after replacing the bulbs, a licensed electrician should be consulted.

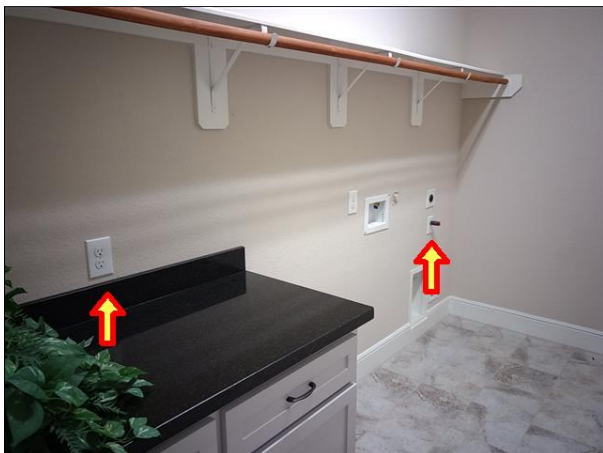
- Two receptacle(s) in the laundry room are not ground fault circuit interrupt (GFCI) protected. This condition is safety hazard that should be repaired.

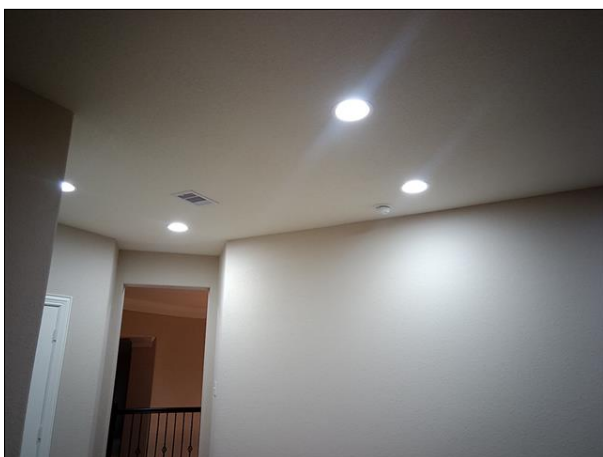
- One switch in the game room are operated by more than one switch, commonly known as a three way switch. The fixtures on this circuit are inoperable unless the the switches are placed in a particular position. This suggests improper wiring that should be repaired.

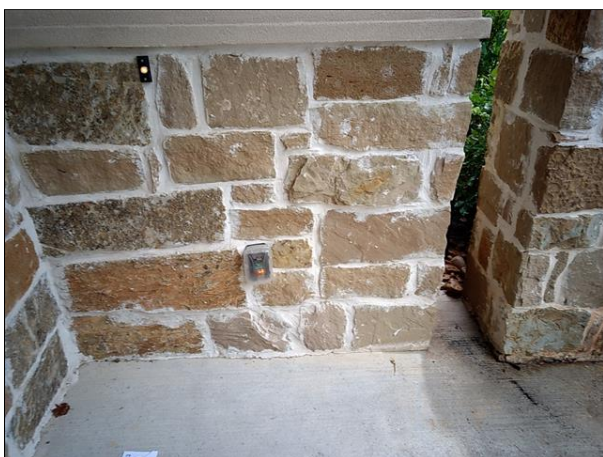
- The receptacle(s) at the exterior are not ground fault circuit interrupt (GFCI) protected. This condition is safety hazard that should be repaired.

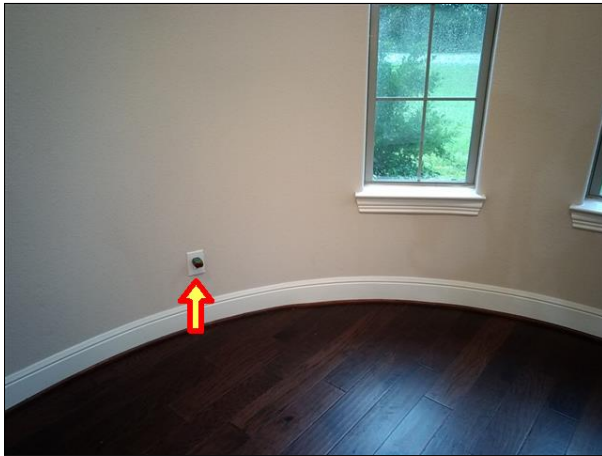
- One receptacle(s) in the dining room is(are) inoperative. Repairs should be performed by licensed electrician.

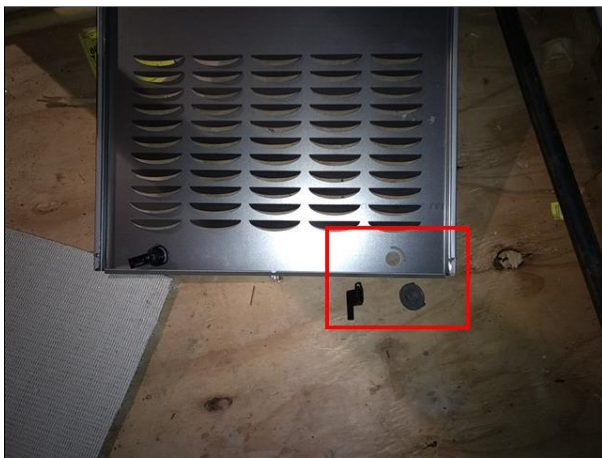
- The locking mechanism for the access panel on the first level furnace does not function correctly. The lock mechanism should be repaired or replaced.

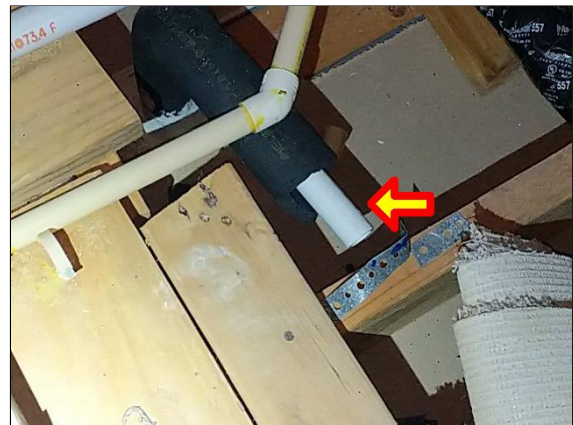
- Condensate drains terminate at grade near the foundation. In newer construction it is common for the drains to terminate into a sewer system.

Condensate rain attic not used.

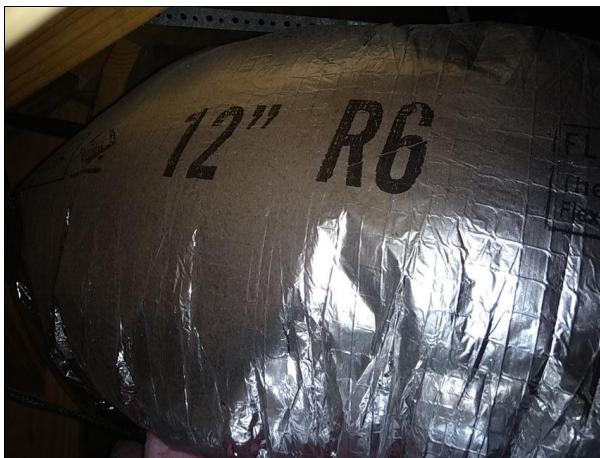
- The supply ductwork is labeled R6. Per current code ductwork in attics and some other areas are required to be R8 in hot spaces such as attics using the "prescriptive method" prescribed in the International Residential Code. Reference 2012 IRC M1103.2.1. R6 ductwork is acceptable when installed as part of, and specified by an recognized energy conservation design program. Details of the design program must be posted in a designated location. This information was not located at the time of inspection.

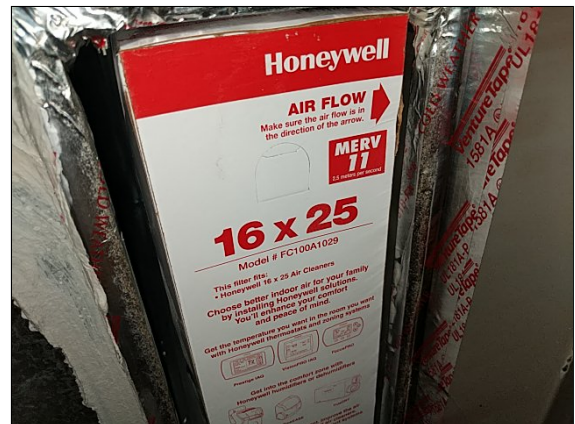
- The media filter(s) at the evaporator in the attic is/are dirty. The filter(s) should be replaced.

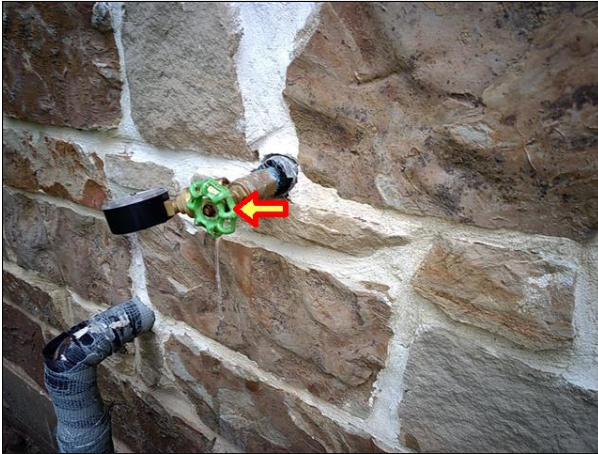
- The hose bib(s) at the left side of the home leaks at the valve stem when turned on.

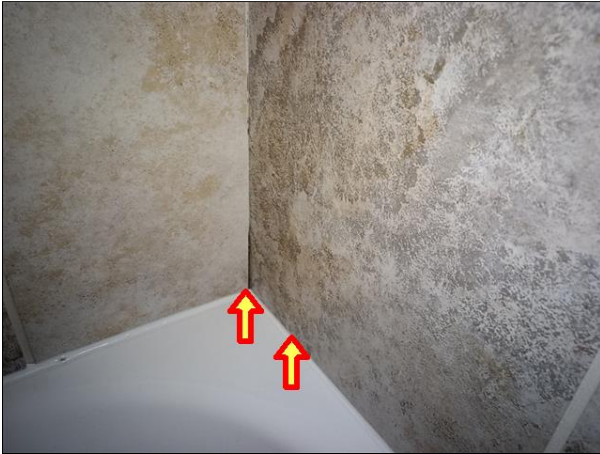
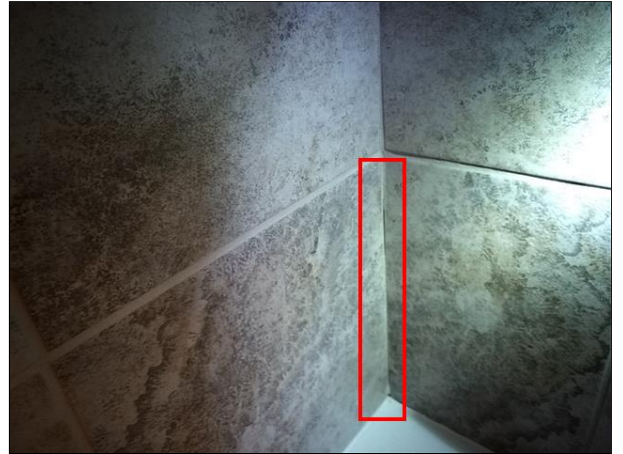
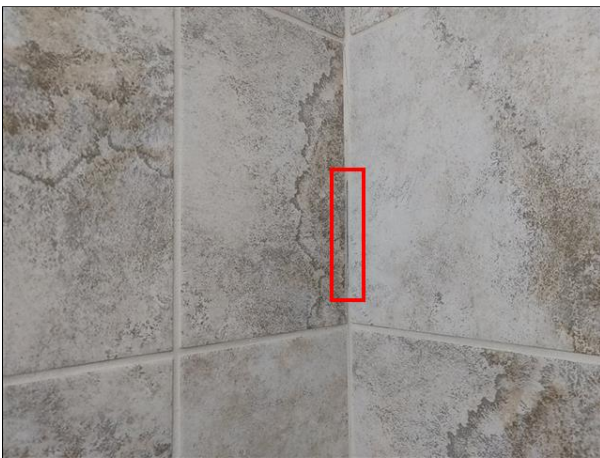
- The drain stop at the left and right sink does not function properly
- Caulk / grout improvements are needed at the tub.

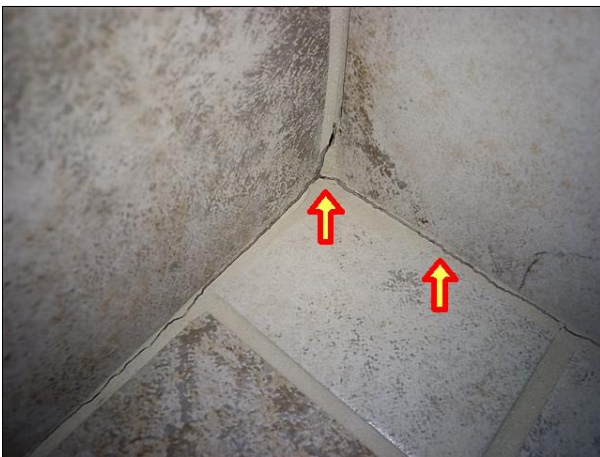
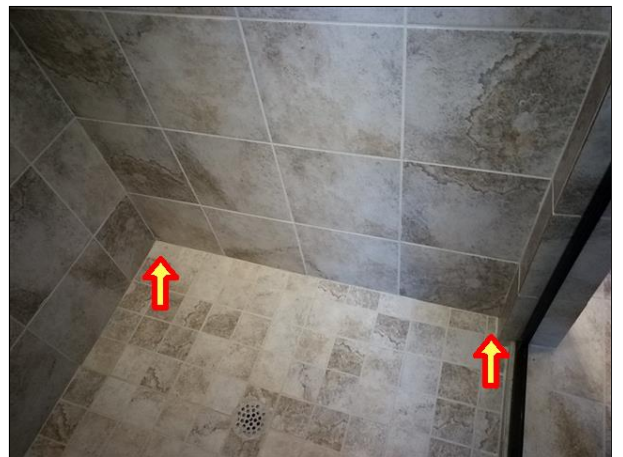
- Caulk / grout improvements are needed in the shower.

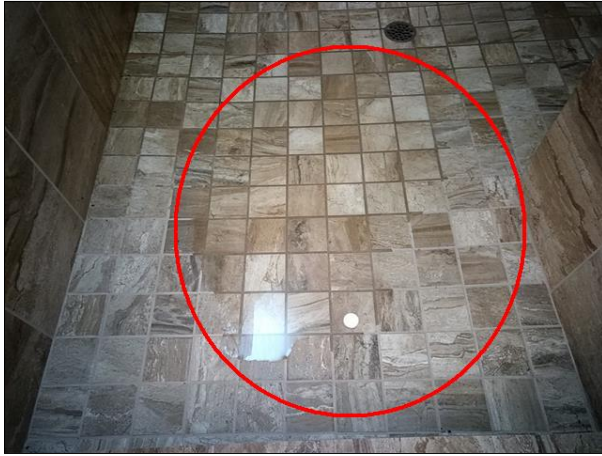
- The shower basin does not drain adequately. Standing water was observed after the shower faucets have been turned off.

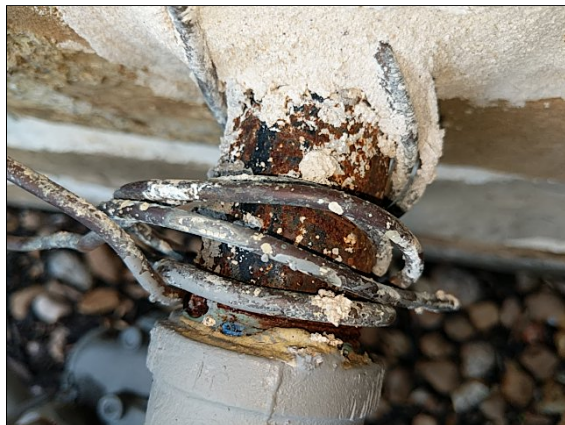
- The gas piping was not coated to prevent corrosion. Over time leaks could occur.

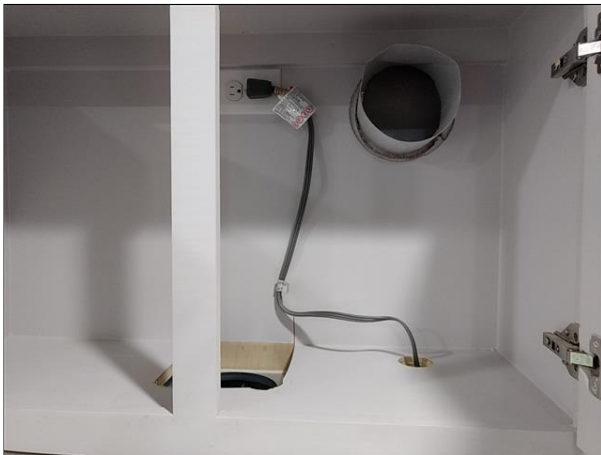
- The range hood vent duct is missing. The range hood vent should be constructed of rigid metal duct.
