# Inspection Report

# PROPERTY INSPECTION REPORT

**Concerning:** Buyers Row, Our Town, TX  
(Address or Other Identification of Inspected Property)

**By:** Sean Kennedy #22935 Bill Harvey #5648 9/4/2020  
(Name and License Number of Inspector) (Date)

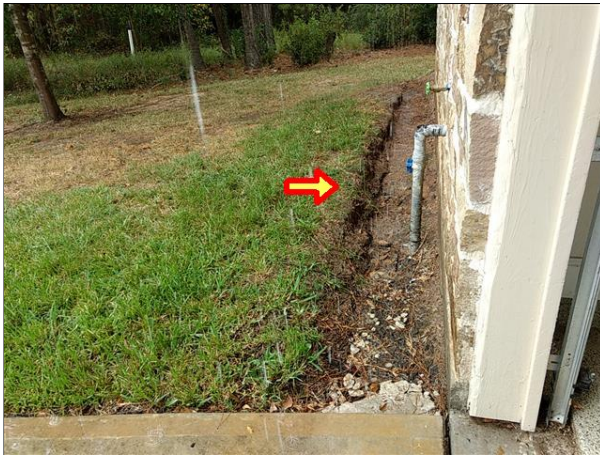
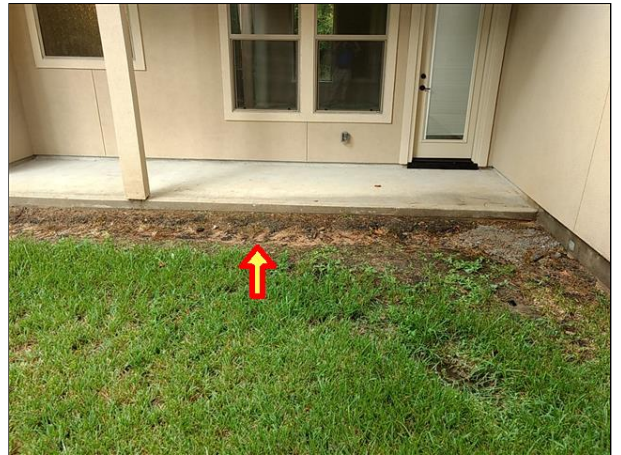
- Grade improvements are needed to direct run off away from the foundation at the left side and rear of the home. Code requires six inches minimum of fall from the foundation in the first ten feet

of grade. Improper grading may promote unstable foundation conditions and water penetration into the home. Improvements should be undertaken by professional landscaper.

Swale ILLUS

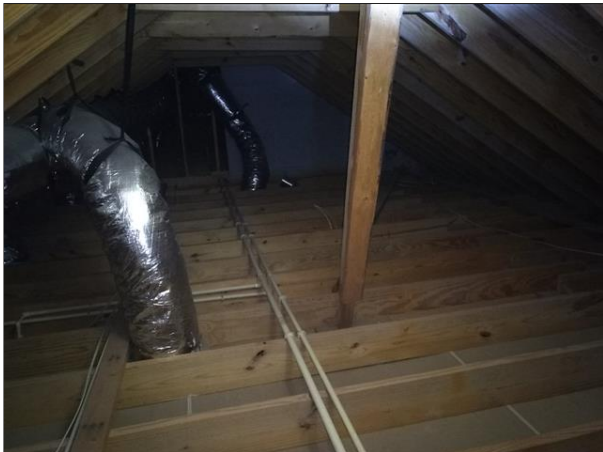
above master suite

- Attic framing appears to be installed and functioning as intended with no major defects observed.
- The attic space is not insulated. The insulation was never installed.

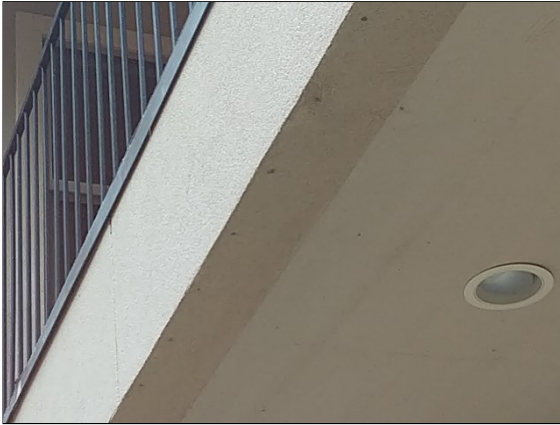
- A moisture relief detail is not installed under the the elevated vertical to horizontal transition at the rear of the home. Moisture relief is needed at the lower edge of elevated walls just as moisture relief is need at walls that terminate near the foundation level. Moisture relief can by

- Cracks have formed on the column below this area suggesting water intrusion into the wall system.

Missing moisture relief detail

created at elevated walls by installing aluminum slotted tracks designed for this purpose, or casing bead can be used to create a small opening. If not repaired structural damage in the wall may occur.

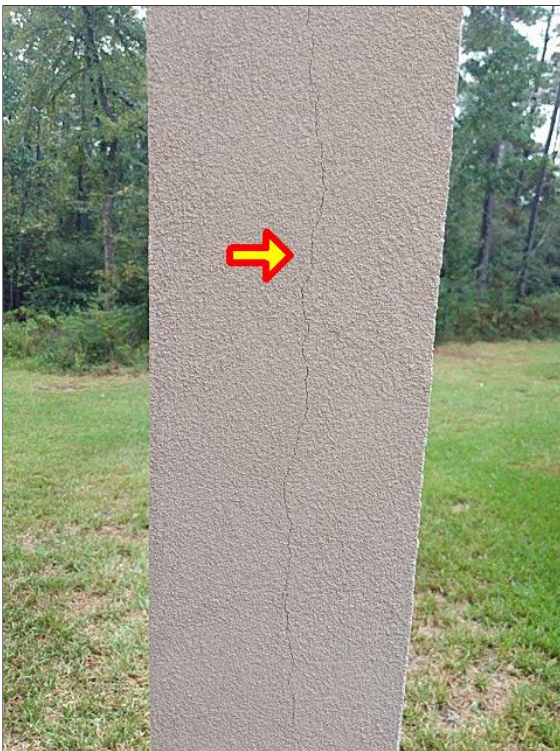
Possible repair

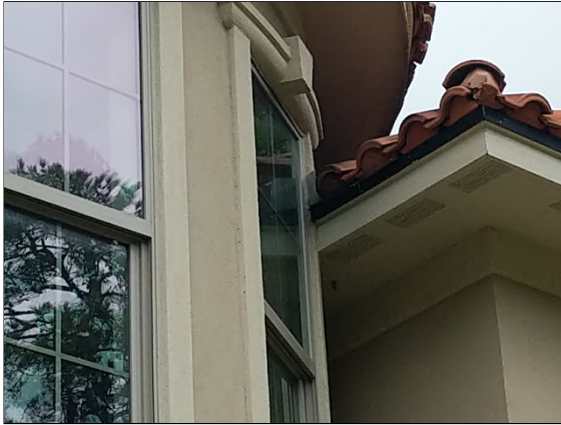
- At the front of the home, the kickout terminates into the window trim band. Terminating the roof edge this close to the window opening can be problematic. What appears to be evidence of water intrusion was observed at the interior.

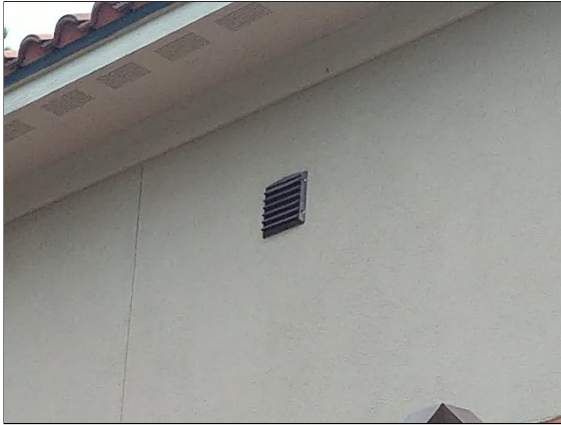
- Caulking at the vent terminations is not installed. Caulking improvements should be undertaken as needed.

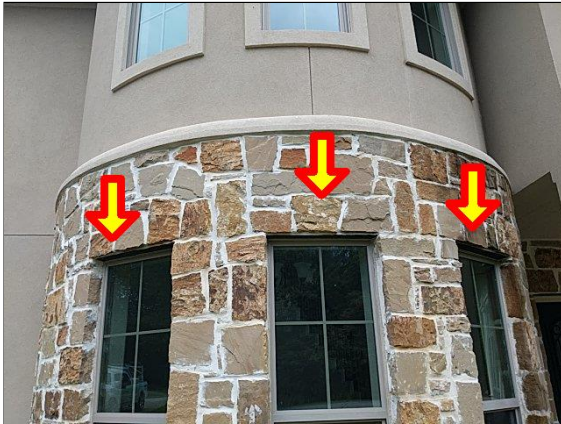
- Weep holes are not installed where required above the windows and along the masonry ledge at the front of the home. Weep holes should be spaced not further that 33 inches on center. Weep hole openings should be a minimum of 3/16 of one inch in diameter.

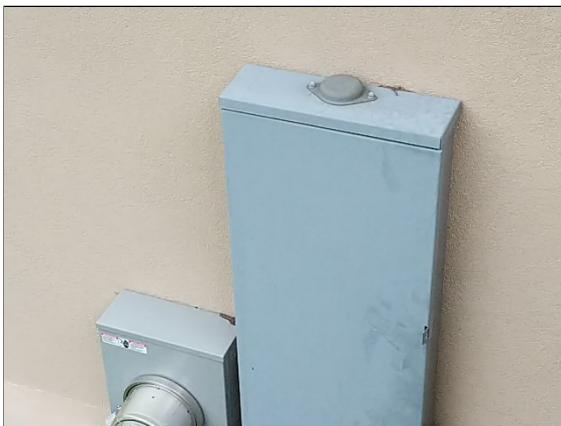
- Caulking is ot installed along the top and sides of the electrical panel.

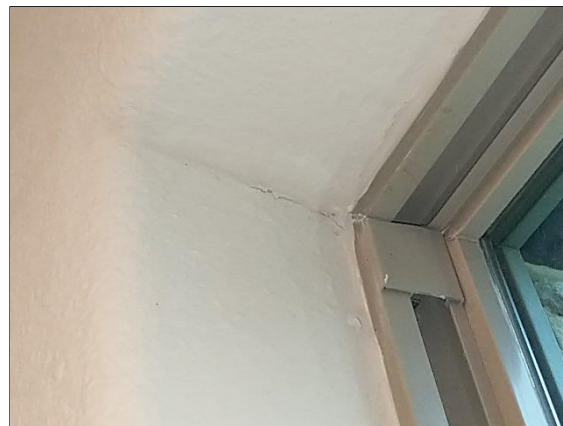
- What appears to be evidence of water intrusion was observed at the walls in the living room.

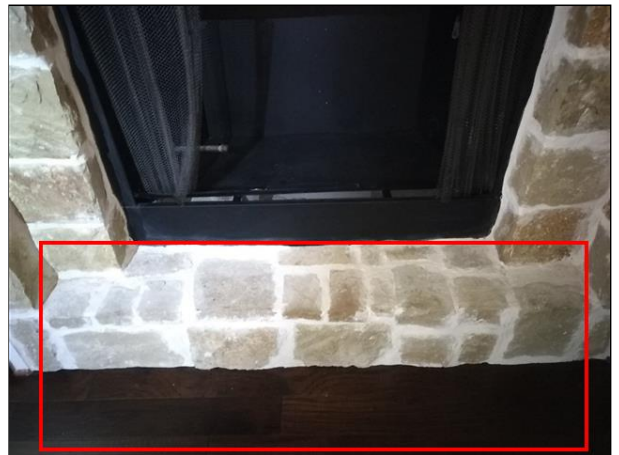
hearth too small

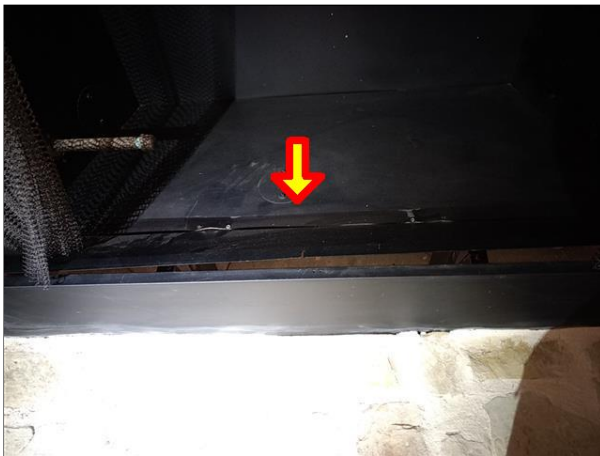
floor is thin gauge metal

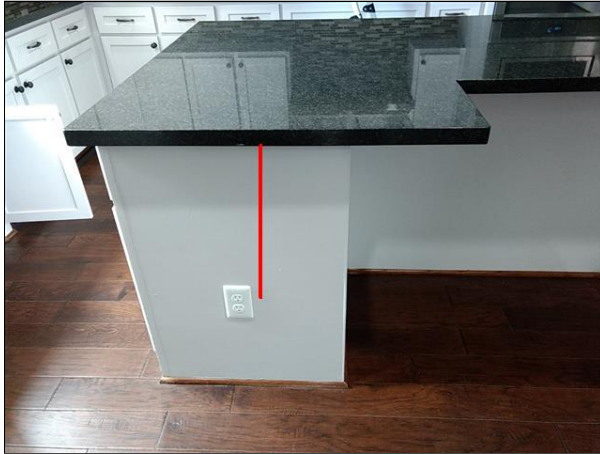
- The receptacle at the kitchen island is installed more than 12 inches below the counter surface.

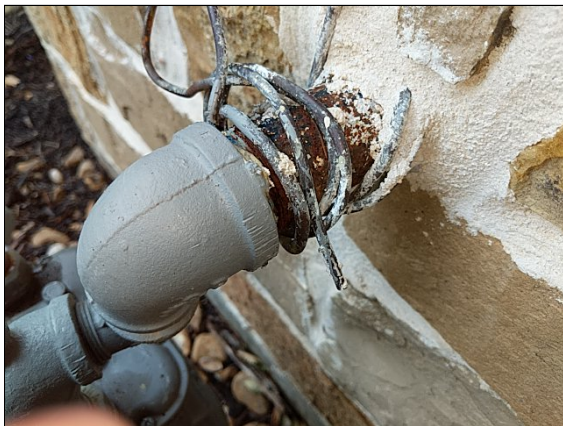
The gas piping is not properly bonded to the grounding system

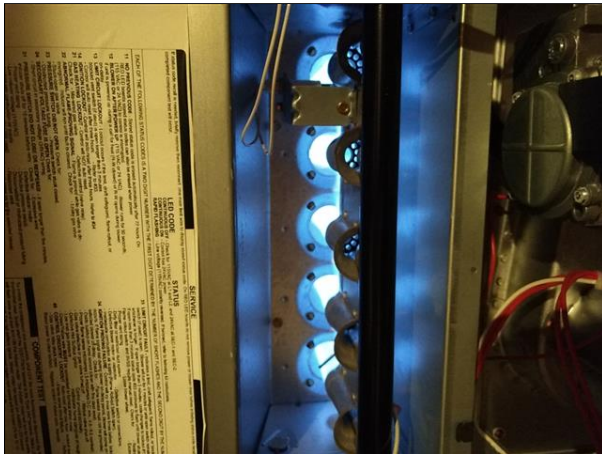
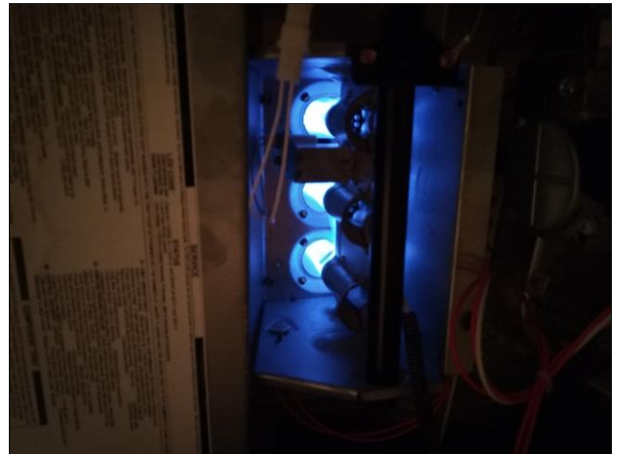
- The furnace were operable at the time of inspection. Though the furnace(s) were operable, some condition needing repair were observed.

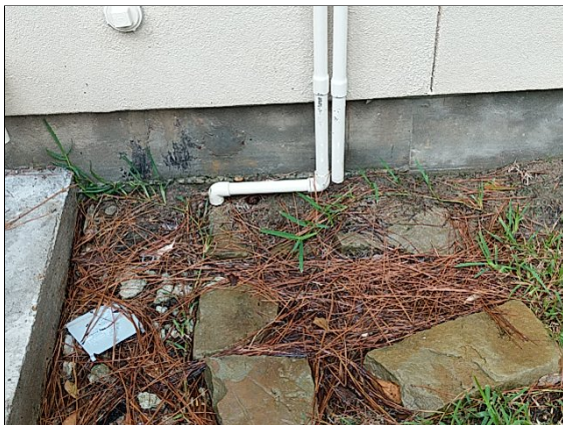
Condensate rain attic not used.

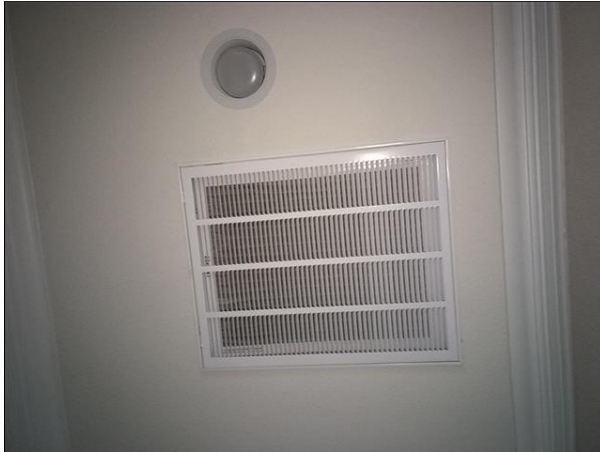
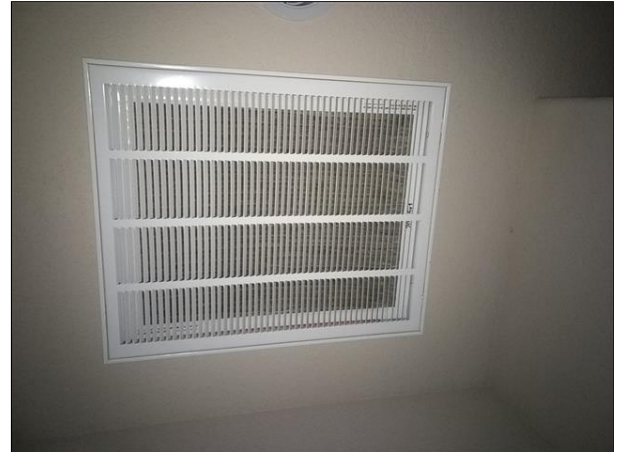
- The supply ductwork is labeled R6. Per current code ductwork in attics and some other areas are required to be R8 in hot spaces such as attics using the "prescriptive method" prescribed in the International Residential Code. Reference 2012 IRC M1103.2.1. R6 ductwork is acceptable when installed as part of, and specified by an recognized energy conservation design program. Details of the design program must be posted in a designated location. This information was not located at the time of inspection.

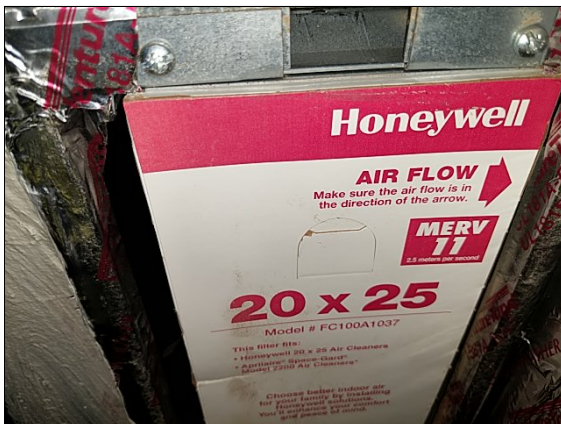
- The media filter(s) at the evaporator in the attic is/are dirty. The filter(s) should be replaced.

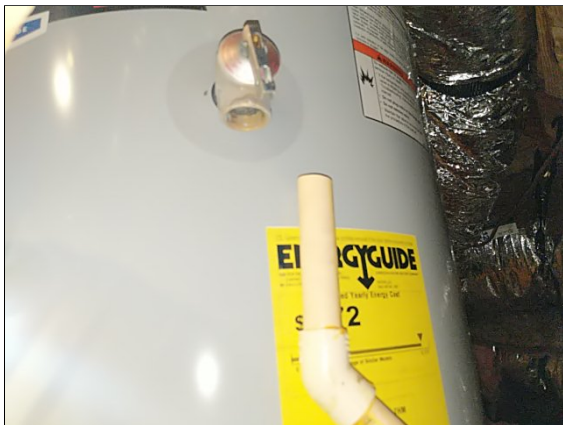
- The drain piping for TPR (temperature / pressure / relief) valve at the water heater is disconnected.

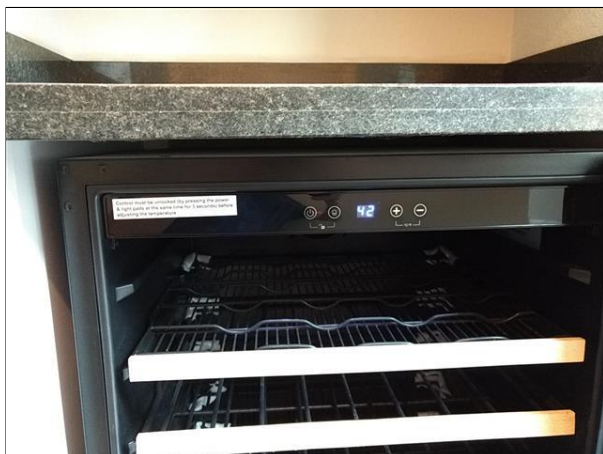
- The wine cooler appears to be properly installed and functioning as intended.
